Case report

Clinical management and microscopic characterisation of fatigue-induced failure of a dental implant. Case report

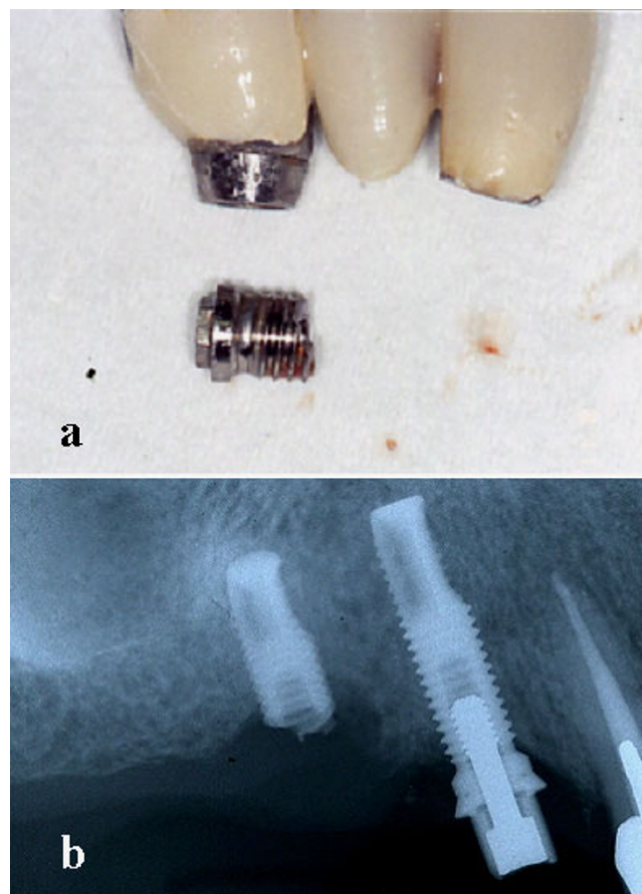
Figure 1

The removed metal-ceramic prosthesis with the fractured implant (a); radiological appearance of the fractured implant replacing the first molar (b).

A middle-age woman was referred to our department for raised mobility of a fixed implant-supported prosthesis replacing the first and second right maxillary premolar and the first molar; the patient referred that implants were placed in September 1996 and loaded after six months. The clinical examination revealed a cemented metal-ceramic prosthesis supported by two thread osseointegrated implants which was easily removed together with the fractured coronal portion; radiographic examination showed the residual portion of the implant (external hex RP Brånemark implant) in 1.6 position and a marginal crater-like bone loss; no signs of periimplantitis or lack of osseointegration were observable (Fig. 1a, b). Under local anaesthesia a mucoperiosteal flap was elevated exposing the fractured implant which was removed by a trephine cutter and the surgical site was regenerated with calcium sulphate (Surgiplaster) also to promote ridge augmentation. Three months later, two thread implants of length and diameter adequate to crestal bone dimension (Brånemark, Nobel Biocare, MKIII, 5 × 10 mm in 1.6 position and 3,75 × 13 mm in 1.5 position), were placed in the regenerated bone (Fig. 2); four months later, a cemented gold-ceramic prosthesis was positioned upon the prosthetic abutments.

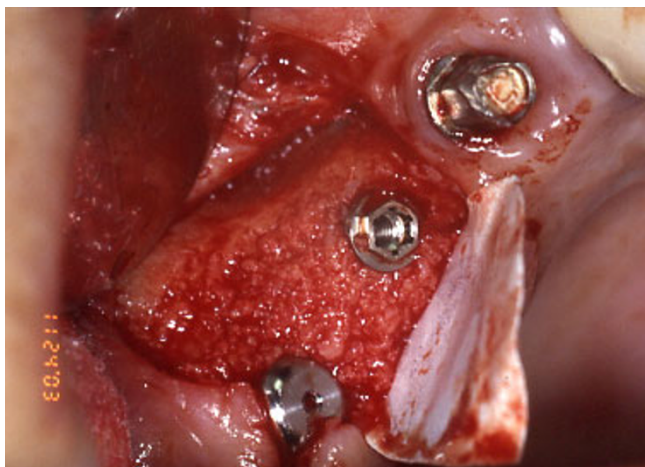
Figure 2
Three months later, two implants were placed in the regenerated bone.

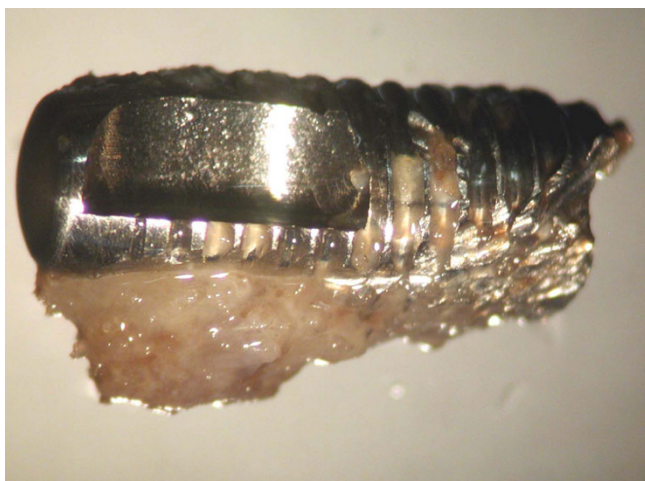
Figure 3
Stereomicroscope imaging showing well-osseointegrated fractured implant.

The fractured implant was observed both at the stereomicroscope and at the confocal laser scanning microscope; it totally measured 3,75 mm of diameter and 13 mm of length and was transversally fractured at the level of the third-fourth thread; the endosseous residual portion was well-osseointegrated as confirmed by the histological evaluation of the perimplant bone which showed no signs of periimplantitis or fibrous integration of the implant (Fig. 3 and 4).

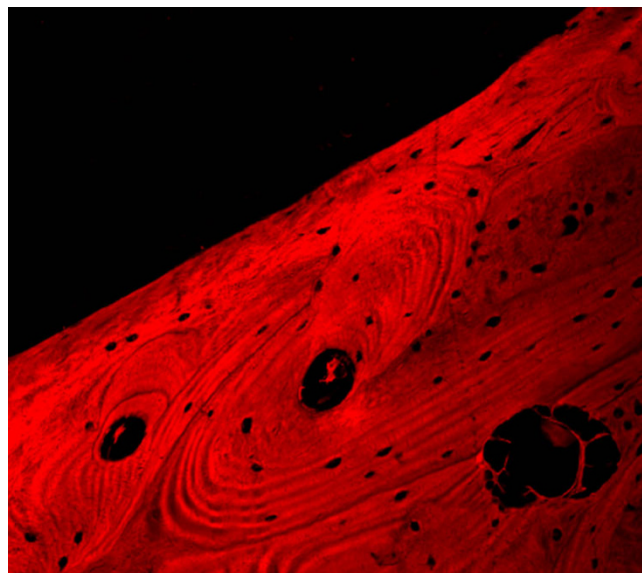
Figure 4
Confocal laser scanning microscopic analysis of the perimplant bone showing no sign of perimplantitis or fibrous integration of the fractured implant; no inflammatory infiltrate is observable at the interface bone-implant.

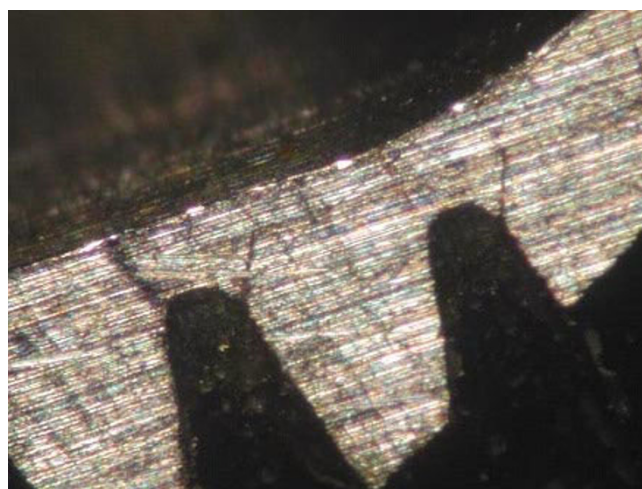
Figure 5
Stereomicroscope analysis: particular of apical screws showing well-defined initial fracture rims at the basis of the screws.

fracture observed by other authors using fractography with scanning electronic microscope (main transversal fracture surface with a variable number of fatigue striations indicating the advancement of the crack front under cycling loading)[11-13]; besides, numerous surface irregularities were also detected on the roots of the screw thread of the well-osseointegrated apical portion of the implant (Fig. 5), probably related to microfractures or cracks, defects of industrial workmanship or finishing touch, or alterations due to implant removal by burs.

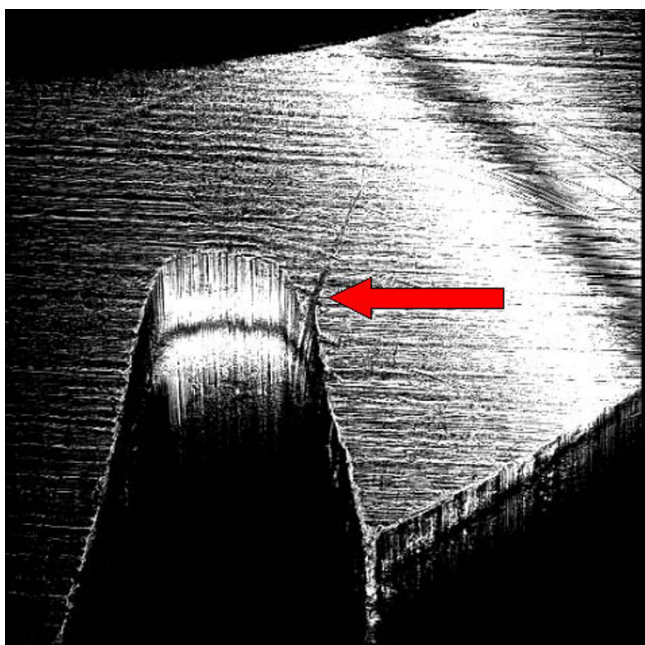
Figure 6
3D CLSM reconstruction: absence of any other damage of the implant surface can exclude other causes than fatigue fracture.

evaluation of the depth of the defects by serial scanning at different focal plans (10 different plans at 3,4 µm of distance) as showed in figure 6 and 7.

Considering the appearance on 3D reconstruction and the presence of the defects in all scanned plans, authors agreed in defining them as microfractures or craks of the apical portion of the implant though well-osseointegrated due to fatigue.

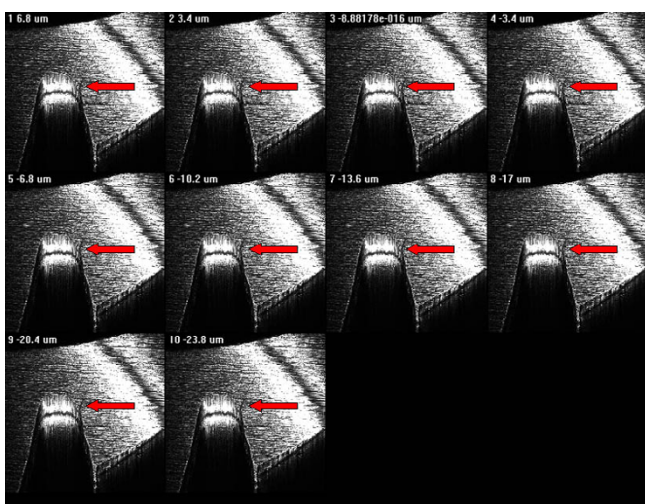
Figure 7
3D CLSM reconstruction: the serial plan scanning imaging shows the complete micro-fracture of the apical screw.
